Contract #: 04-0120F4Cty: SF/ALA Rte: 80 PM: 13.2/13.9File #: 69.28**WELDING INSPECTION REPORT****Resident Engineer:**Pursell, Gary**Address:** 333 Burma Road**City:** Oakland, CA 94607**Report No:** WIR-016105**Date Inspected:** 10-Aug-2010**Project Name:** SAS Superstructure**OSM Arrival Time:** 700**Prime Contractor:** American Bridge/Fluor Enterprises, a JV**OSM Departure Time:** 1900**Contractor:** Zhenhua Port Machinery Company, Ltd (ZPMC), Changxing Island **Location:** Shanghai, China**CWI Name:** Li Yang**CWI Present:** Yes No**Inspected CWI report:** Yes No N/A**Rod Oven in Use:** Yes No N/A**Electrode to specification:** Yes No N/A**Weld Procedures Followed:** Yes No N/A**Qualified Welders:** Yes No N/A**Verified Joint Fit-up:** Yes No N/A**Approved Drawings:** Yes No N/A**Approved WPS:** Yes No N/A**Delayed / Cancelled:** Yes No N/A**Bridge No:** 34-0006**Component:** OBG Components**Summary of Items Observed:**

On this date Caltrans OSM Quality Assurance (QA) Inspector, Dan Hernandez was present during the times noted above to observe the fit up, welding and related activities associated with the fabrication of the San Francisco Oakland Bay Self Anchored Suspension Br

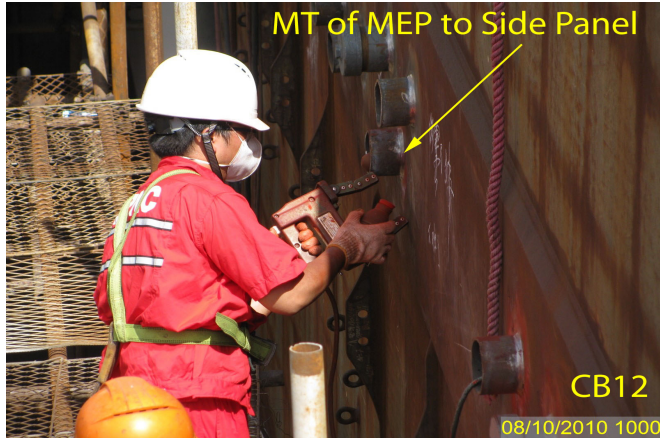
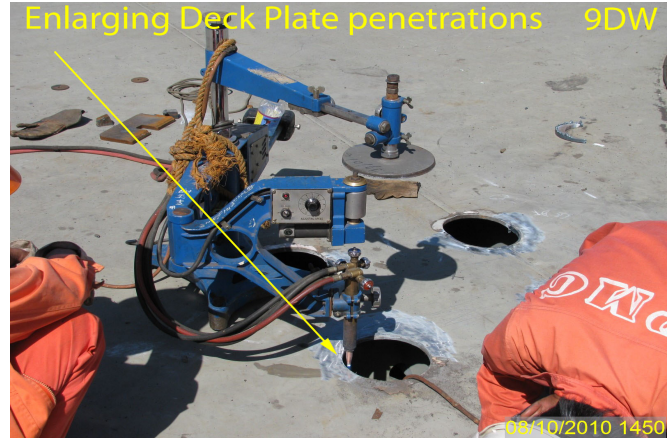
This QA Inspector observed 8 (eight) Deck Plate penetrations for lifting assembly being enlarged with the use of a mechanical guided torch at panel point 80.
